# What Experts Say About The DynaPier®

**DynaPier®**

Simply the best foundation solution.

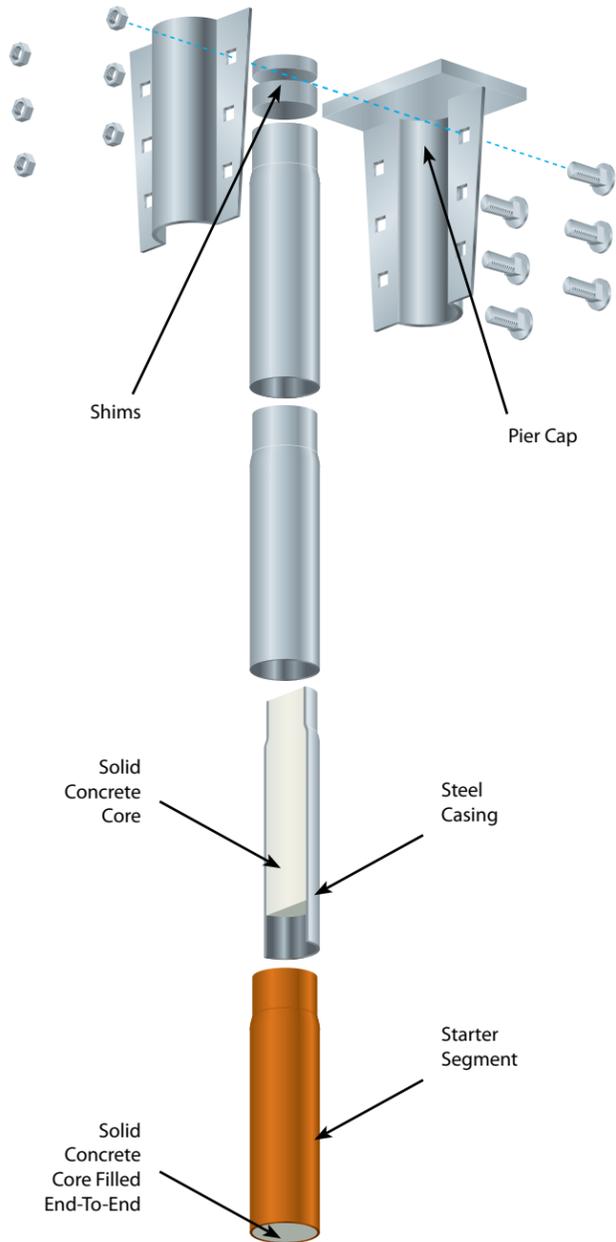
## Technical Specifications:

DynaPier® segments are comprised of 2 7/8" diameter 8 gauge powder-coated tubing. The steel segments are pre-cast with a 8,800 psi concrete mix. Segments that have cured for 28 days can withstand compressive loads in excess of 75 tons.

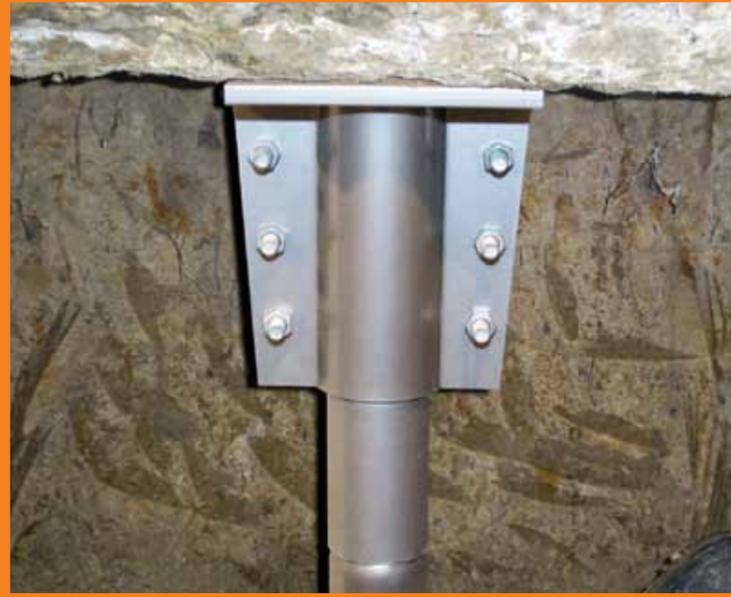
## The Unique DynaPier® System

The DynaPier® system was designed to be the strongest foundation pier in the industry by combining steel and high strength concrete. It is installed centrally beneath the footing rather than outside of the footing, thus transferring the structural load directly on top of the pier. The DynaPier® will achieve the greatest depth while installed in a position to provide the greatest support. **No other piercing system can make these claims.**

The patented DynaPier® is comprised of high-strength concrete that is pre-cast in a steel sleeve which provides superior shear strength and compressive resistance as proven by independent testing labs. The outer casing is filled with a concrete core, and cured for maximum strength. The DynaPier® segments are hydraulically driven into the ground one at a time. After one DynaPier® segment is driven, another segment is connected to the pier, and the process is repeated until the foundation pier hits bedrock or a dense strata of subsurface material. A temporary platform is attached to the pier so that the structure can be lifted. Once the desired lift is achieved the pier is extended up to the footing and the pier cap is attached to the pier.

- **The pier is located centrally and directly beneath the foundation footing.**
- **ALL parts are connected to form a monolithic pier.**
- **ALL shims are contained within the pier cap.**
- **Installation does not require removal or breaking of the footing; footing remains completely intact.**

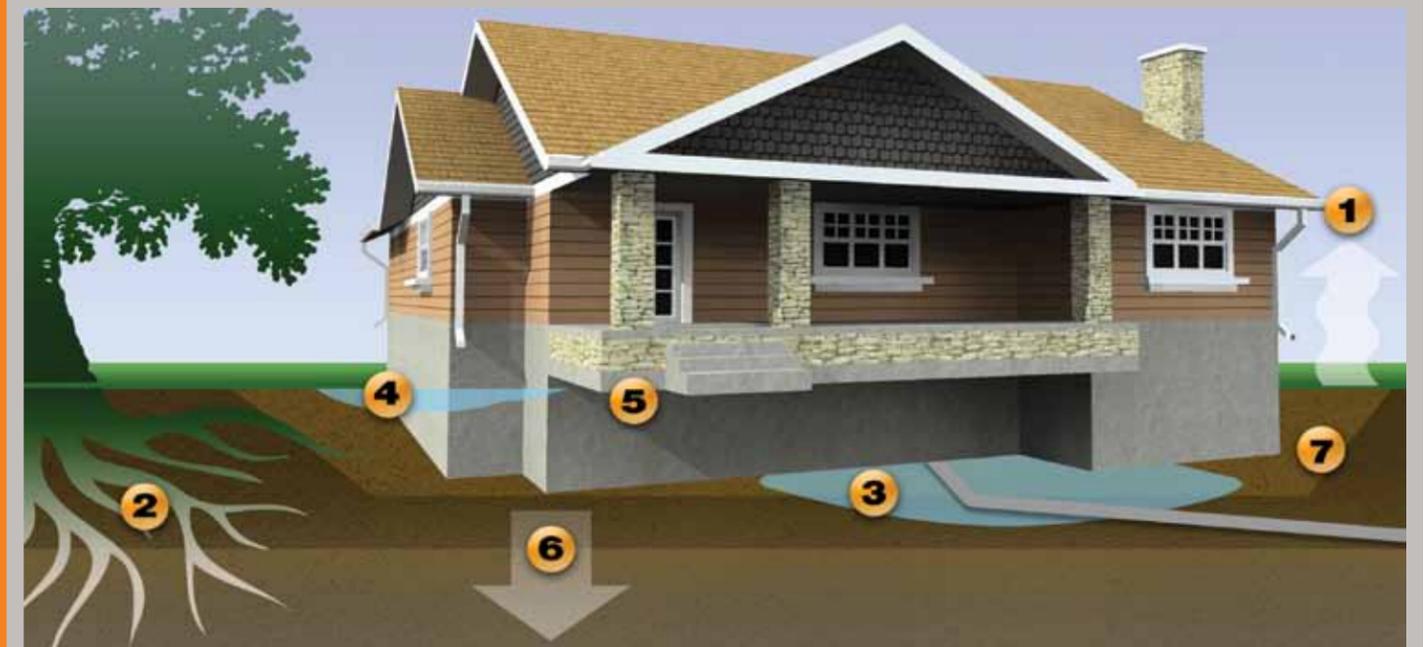
## Causes Of Foundation Problems

1. **Evaporation:** Hot dry wind and intense heat will often cause the soil to shrink beneath the foundation. This settlement may cause cracks to appear throughout the structure.

2. **Transpiration:** Tree roots may desiccate the soil beneath a home causing the soil to shrink and the home to settle.
3. **Plumbing Leaks:** Water from plumbing leaks is often a cause of foundation problems.

4. **Drainage:** Improper drainage is one of the leading causes of foundation failure. Excess moisture will erode or consolidate soils and cause settlement.

5. **Inferior Foundation Construction:** Insufficient steel and inferior concrete will contribute to movement in the slab.
6. **Inferior Ground Preparation:** Soft, low density soils and/or improperly compacted soil beneath a home is the leading cause of foundation failure. Cut and fill methods are a leading cause of foundation settlement.

7. **Poor Soil Conditions:** Poor soil and its expansion and/or contraction contribute to foundation failure.
